## DFM Report

<b>Product Name:</b>	<b>Tucson</b>
<b>Prepared By:</b>	<b>Benjamin Vo</b>
<b>Report Rev:</b>	<b>V15</b>
<b>Date:</b>	<b>2020-5-16</b>
<b>Page:</b>	<b>33</b>

Customer Name	SOLETRON
Product Name	Tucson
Assembly P/N & Rev	BT3217
PCB P/N & Rev	A9876

CAD Data Source	Gerber + Centroid XY
CAD File	BT3217.txt
BOM File	BT3217.xlsx
Matched Component (PN)	91.11%
Matched Component (RefDes)	95.06%
Size L x W(mm)	78.672 x 52.456
Thickness (mm)	1.600
Number of layers	2
Single or double reflow	Double Side
Through hole parts on 1 or both sides	None

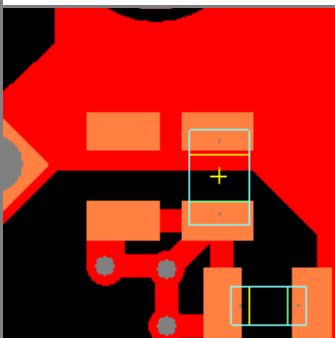
#	Location1	Location2	Std Value	Act Value(mm)	Image Captured	Comment
1	Top Component 2007 27.050 22.000	Top Component 2008 27.050 22.000	=>14mil(0.35 mm)	0.000

The position 2007 & 2008 are in same location, one of them may be a wrong location, please check in the data "3112 293 39383_A_125_08-Jan-2020.txt". Notice: both position 2007 & 2008 are in the BOM.
2	Top Component 2019 55.750 30.600	Top Component 7705 55.750 29.800	=>14mil(0.35 mm)	0.000

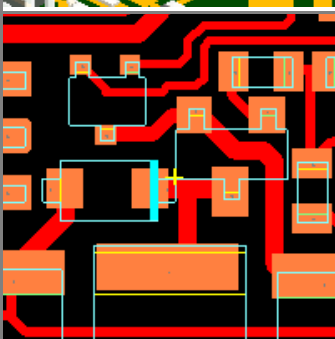
The position 7707 & 6004 are too close, it will cause assembly issue. The root cause may caused by the 6004 and it is not match with the land pattern, the part size has a little big.

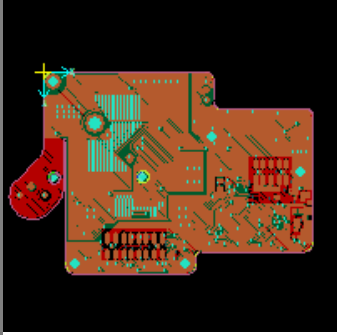
No fiducial mark on bottom side

There are no standard fiducial marks on bottom side. It is recommended to design two marks on the diagonal of the PCB.

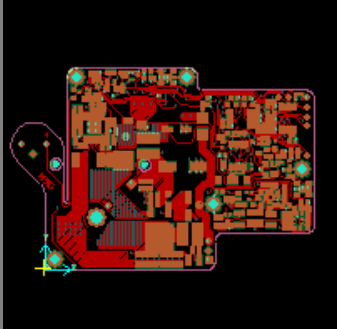
Top side no fiducial mark

There are no standard fiducial marks on top side. It is recommended to design two marks on the diagonal of the PCB.

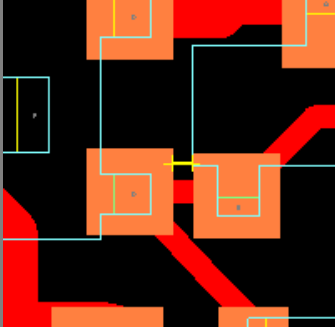
#	Location1	Location2	Std Value	Act Value(mm)	Image Captured	Comment
1	Top Pads 7705 58.052 29.652	Top Component 6002 57.848 29.652	=>10mil(0.25 mm)	0.204

The distance between the device and the pad is too close, and the device will contact the pad when the mounting offset is allowed, resulting in soldering problems.

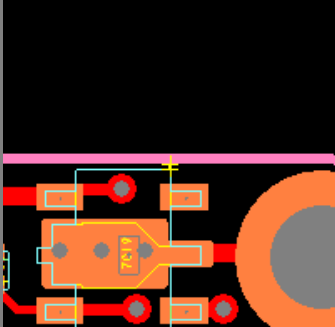
#	Location1	Location2	Std Value	Act Value(mm)	Image Captured	Comment
1	Top Component 7019 32.850 52.150	LINE 32.850 52.273	=>14mil(0.35 mm)	0.123

The distance between the device and the board edge is too close, which can cause damage to the device during assembly and handling.

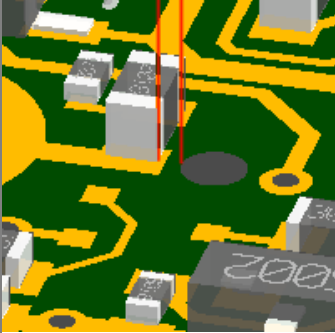
#	Location1	Location2	Std Value	Act Value(mm)	Image Captured	Comment
1	Top Component 2018 62.400 25.900	XdrI001.drl PAD 62.750 25.900	=>40mil(1mm)	0.350

The small chip component and the NPTH hole are too close to each other, which can cause offset in reflow process (especially hot air reflow soldering equipment).

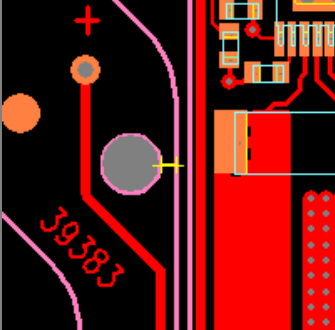
#	Location1	Location2	Std Value	Act Value(mm)	Image Captured	Comment
1	XdrI001.drl PAD 4.200 27.400	LINE 5.000 27.400	>2mm(80mil)	0.800

The thickness of the PCB is 1.6mm but the distance from the tooling/screw hole to the edge of the board is smaller than the size, which may cause damage during assembly.

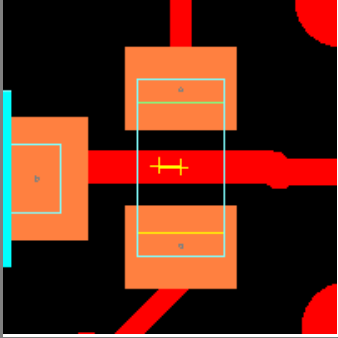
#	Location1	Location2	Std Value	Act Value(mm)	Image Captured	Comment
1	Top Component 3024 19.863 47.100	art001.pho LINE 20.050 47.100

The trace under chip component is not standard design, which may cause tombstone issues during reflow process.
2	Top Component 3116 7.650 39.475	art001.pho LINE 7.650 38.750

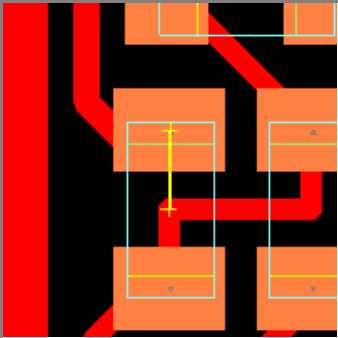
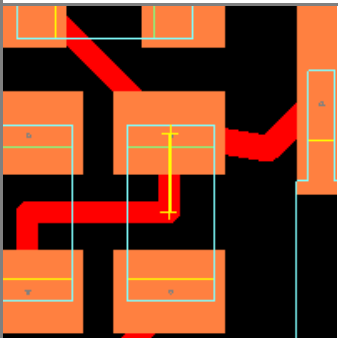
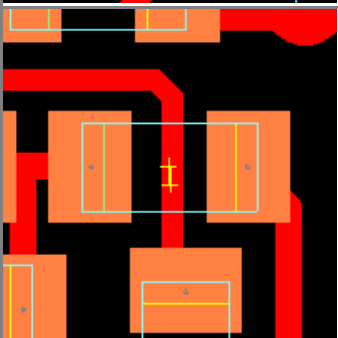
Trace under chip component

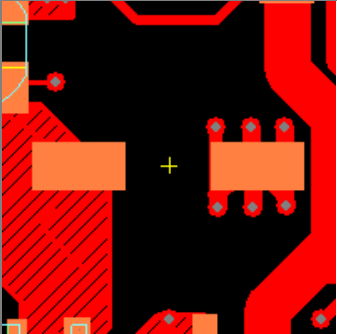
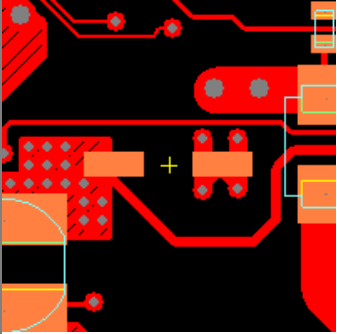
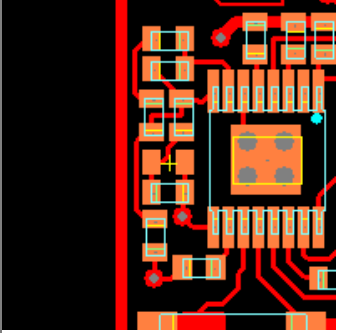
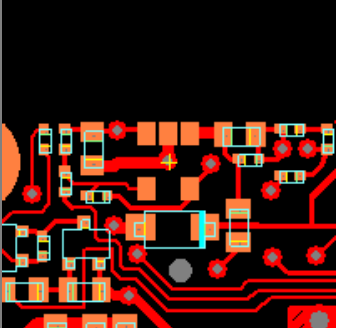
We did not find the datasheets for these devices, so we did not check its assemblability, which requires human confirmation.
2	TOP 2011 34.000 36.450	2011 34.000 36.450

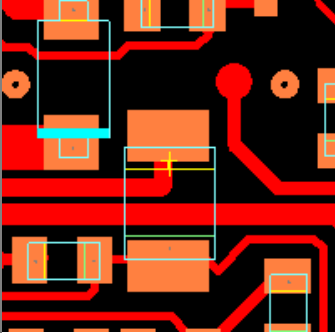
#	Location1	Location2	Std Value	Act Value(mm)	Image Captured	Comment
1	Top Component 5002.2 59.300 24.050	Top Pads Same value pin:5002.1 59.300 24.200	0mm	-0.149

The device and land pattern do not match and there is soldering quality issue. PartNumber:8212 009 52006 Shape: L1206 MPN:74479888310 MFG: WTH

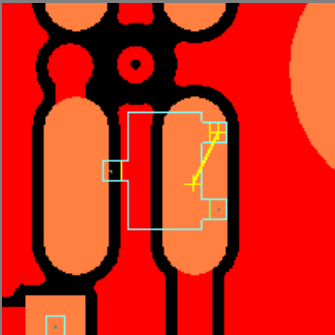
Format: a/b						
#	Location1	Location2	Std Value	Act Value(mm)	Image Captured	Comment
1	Bottom Component 7706.2 62.900 27.950	Bottom Pads 63.300 27.050	0.9~1.1	0.191

May be the position 7706 is a wrong position, because there is no footprint available.

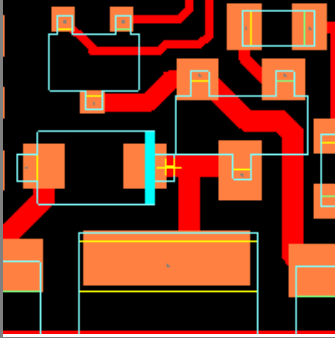
1	Top Component 6004.1 54.550 16.850	Top Pads Same value pin:6004.2 54.375 16.850	0.15~0.55m m(6~22mil)	-0.174

The component size from the BOM is not match with the land patten, it will cause assembly issue. PartNumber:9340 610 56115 Shape:SOD323 MPN:PMEG6010CEH MFG:NXP
---	---	--	--------------------------	--------	---	--

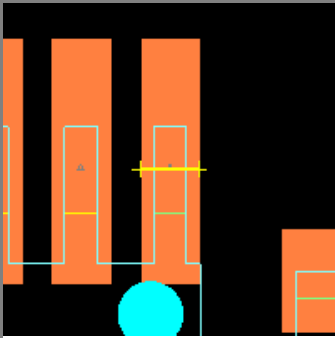
#	Location1	Location2	Std Value	Act Value(mm)	Image Captured	Comment
1	Top Component 7024.1 15.091 39.738	Top Pads Same value pins:7024.2~ 7024.17 14.671 39.738	0.02~0.10m m(0.8~4mil)	0.180

The pads are too wide, which will reduce the electrical gap between the pads for fine-pitch devices. PartNumber:8212 323 71346 Shape: TSSOP-16EPG MPN: LM5088MHX-1/NOPB MFG: TI
2	Top Component 7013.1 47.775 26.662	Top Pads Same value pins:7013.2~ 7013.14 48.225 26.662	0.02~0.10m m(0.8~4mil)	0.210

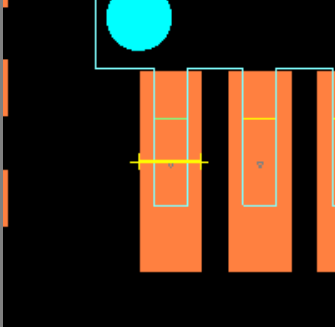
PartNumber:8212 000 70202 Shape: TSSOP-14A MPN: LM2901PT MFG:ST

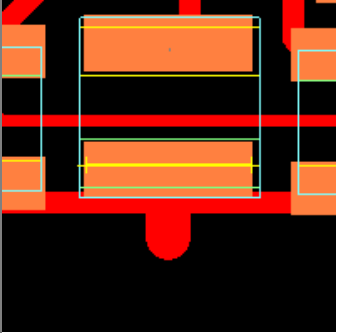
<p>Format: A-B</p>	
#	Location1	Location2	Std Value	Act Value(mm)	Image Captured	Comment
1	Top Component 5005.1 52.550 12.100	Top Pads Same value pin:5005.2 56.250 12.100	-0.1~0.10mm (-4~4mil)	-0.299

The device and land pattern do not match and there is soldering quality issue. PartNumber:8212 102 50868 Shape:NR4XXX MPN:NR4018T221M MFG:TAY

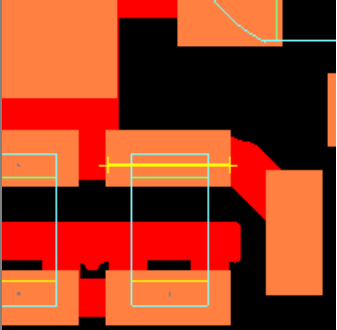
<p>Format: A-B</p>	
#	Location1	Location2	Std Value	Act Value(mm)	Image Captured	Comment
1	Top Component 2120.1 35.550 4.050	Top Pads Same value pin:2120.2 32.950 4.050	-0.1~0.10mm (-4~4mil)	1.000

The component size from the BOM is not match with the land patten, it will cause assembly issue. PartNumber:8212 102 21205 Shape:C1210 MPN:UMK316BJ225KD-T MFG:TAY

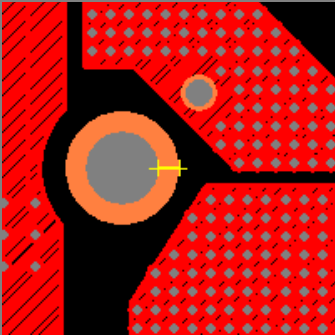
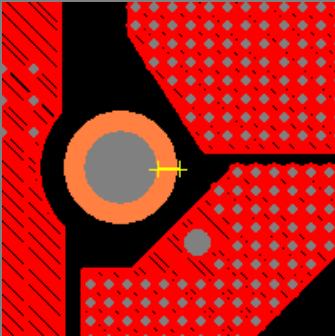
#	Location1	Location2	Std Value	Act Value(mm)	Image Captured	Comment
1	XdrI001.drl PAD 15.800 13.350	Top Pads PAD 14.900 13.350		0.900

the NPTH hole has the copper annular ring, it is not a standard design, it may be a wrong design, please check and confirm in the file XdrI001.rep
2	XdrI001.drl PAD 15.800 13.350	Bottom Pads PAD 14.900 13.350		0.900

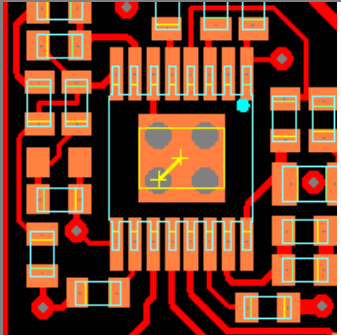
1	XdrI001.drl PAD 11.850 36.050	Top Pads 12.606 36.830

<p>The hole size is too big on position 7024's thermal pad, it may cause solder issue, the recommended hole size on thermal pad is 0.012~0.016 inch.</p> <p>Notice: current hole dia.=0.037 inch</p>
---	--	------------------------------	--	--	---	--

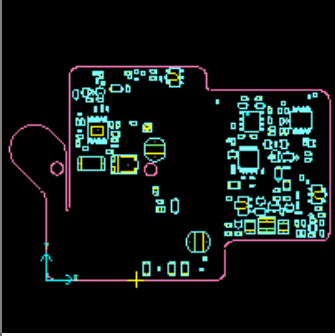
#	Location1	Location2	Std Value	Act Value(mm)	Image Captured	Comment
1	22.236 -0.176	22.236 -0.176	>80%	50.58%

The PCB has an irregular shape, which is not conducive to automated assembly, and it is recommended to be designed as a panelization which the shape and size meets the manufacturing requirements.

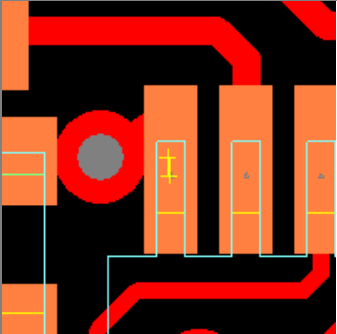
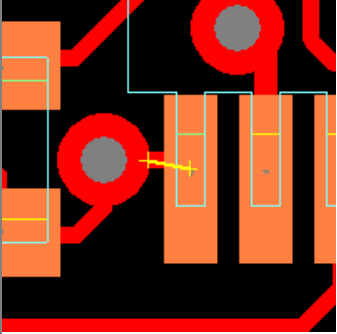
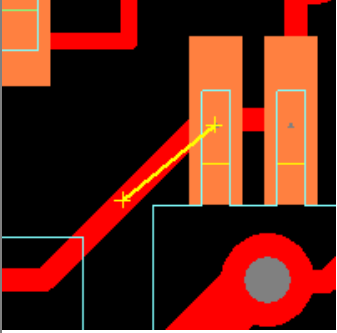
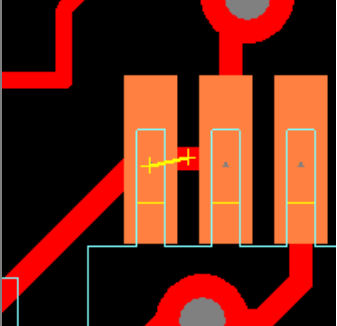
#	Location1	Location2	Std Value	Act Value(mm)	Image Captured	Comment
1	Top Component 7009.14 60.850 42.180	art001.pho LINE 60.825 42.350

Layout the trace from the wide side of the pad is not a standard design, which will cause abnormal solder joint shapes. The recommended design is to lead from the narrow side of the pad.
2	Top Component 7009.1 60.850 36.420	art001.pho LINE 60.475 36.500

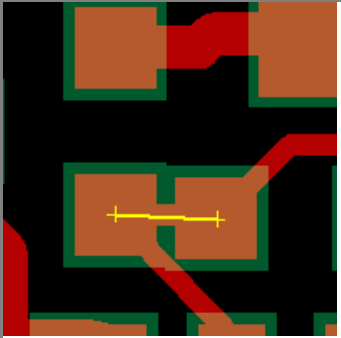
1	art001.pho 58.548 29.309	sm001021.p ho 57.391 29.348

A micrograph of a printed circuit board (PCB) showing two copper pads. A yellow bridge is drawn between the two pads, indicating a recommended solder mask bridge. The pads are surrounded by a green solder mask, and there are red traces visible on the board.	It is recommended to add a solder mask bridge between the two pads.
---	--------------------------------	--------------------------------------	--	--	---	---
